## Investigation of the structural damage caused by blasting activities in tunnels to surrounding buildings: The case of Gümüşhane belt highway

Mehmet Tevfik SEFEROĞLU<sup>1</sup>

<sup>1</sup>Gümüşhane University, Department of Civil Engineering, 29100, Gümüşhane, Türkiye

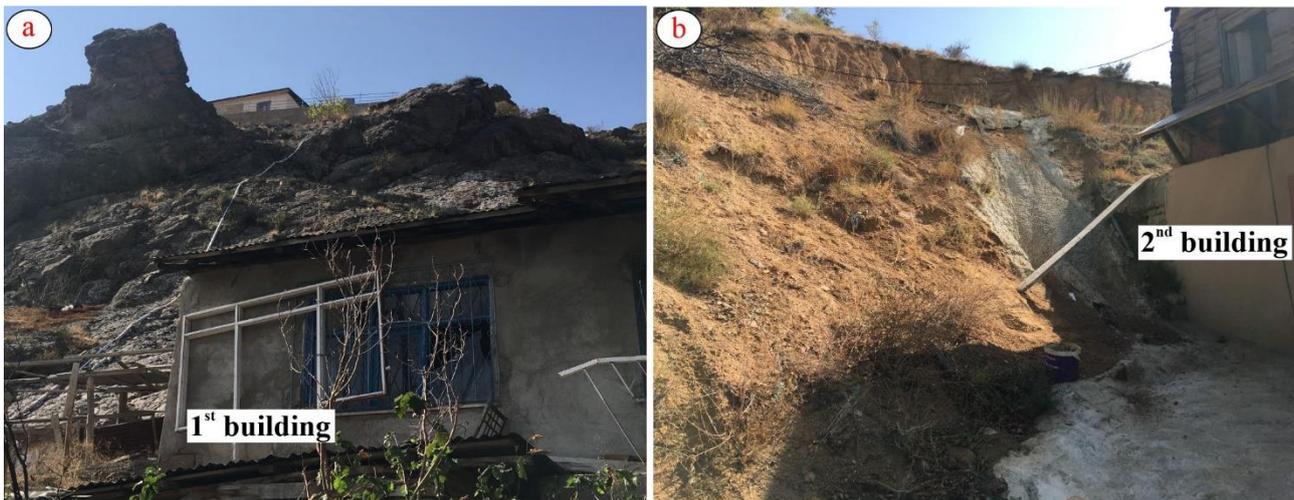
Alibaba Formation (Tokel, 1977) is observed in the area where the 1st building 7 m northwest of the left tube exit of the T2 tunnel. This formation mainly consists of andesite, basalt and their pyroclasts. Although the rocks in the formation are generally observed in fissured and fractured structures, the andesitic rocks at the basement of the 1st building are massive (Figure 7a). The distance between the 2nd building and the explosion/excavation site (entrance of T3 tunnel right tube) is measured as approximately 60 m. In addition, the distance of the building to the direction of the tunnel is measured as 7 m The geological units in the building area and the tunnel construction site are similar. Besides, Gümüşhane Granitoid (Yılmaz, 1972; Topuz et al., 2010), which outcropped generally as fractured and formation of sand by weathering (arenization) of granite, are observed in the area of the 2nd building and T3 tunnel (Figure 7b).

**Figure 7.** Field view of (a) the fissured and fractured andesite and (b) arenization of granite

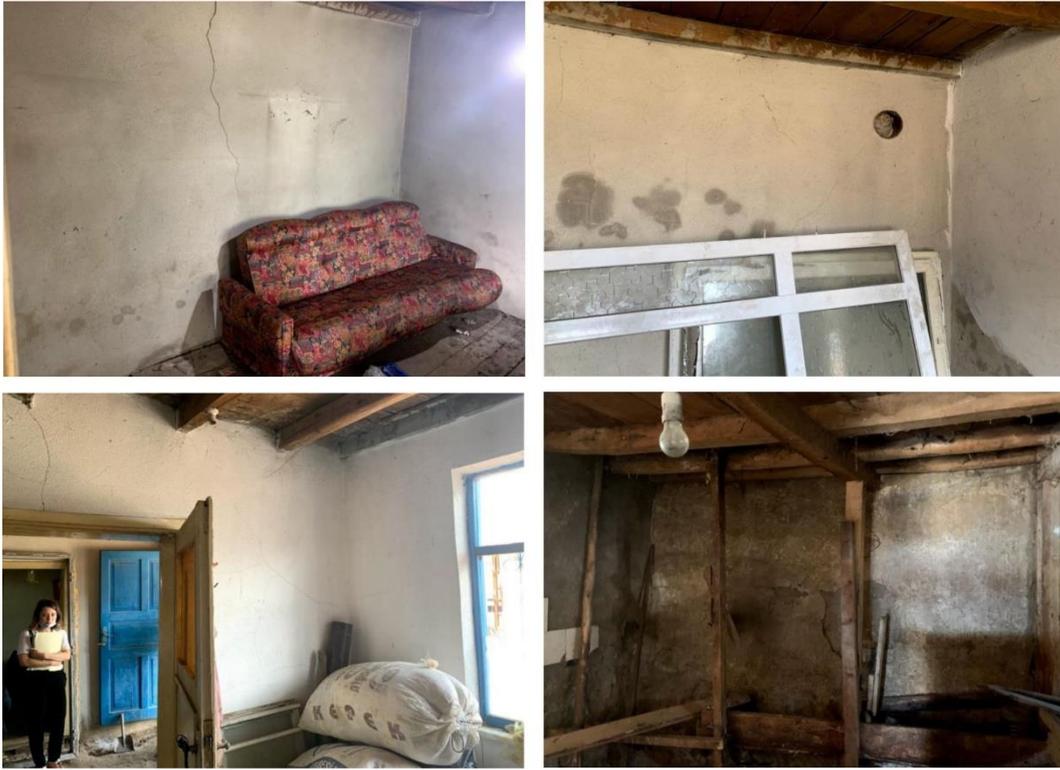
After the observations and examinations made in the field, the 1st building was determined as a class b (i.e., masonry brick buildings such as plastered briquette, briquette, adobe or brick house). These types of buildings are among the building types that can be damaged even at low vibration velocity that may occur after blasting. Therefore, the V<sub>0</sub> speed in the foundation of the building should not exceed 5 mm/sec according to Table 3. The vibration speed value generated by a blasting at the exit of the T2 tunnel calculated in Table 5 at a distance of 7 m was 385.68 mm/sec. It is observed that the vibration values on the foundation (V<sub>0</sub>) of the 1st building created by this vibration are between 192.84 mm/sec and 77.14 mm/sec. The fact that these vibration values are above the limit value of 5 mm/sec indicated that the cracks that may occur in the 1st building may be caused by blasting.

As a result of the damage investigations carried out on the 1st building, it is determined that deep and surface cracks are formed in the load-bearing walls of the building, there are spillages in the wall plaster, fractures occurred in the windows, and the roof pillars in the attic are separated from the floor. The visuals regarding the damage detected on the building are shown in Figure 8.

Damaged parts detected in the building are also located on the masonry walls that form the load-bearing system of the building. Crack openings in the walls vary between 1-5 mm. Although it is necessary to renew the roof in order to eliminate the damage on the roof, the carrier system should be given priority when looking at the condition of the ceiling floor and walls on which the roof will sit. There are also damaged parts on the supporting walls. Considering the current condition, age and depreciation of the building, it will be appropriate and reliable to be demolished and rebuilt. Due to the severe damage to the building, accommodation is not suitable.

**Figure 8.** Damaged parts detected in the 1st building

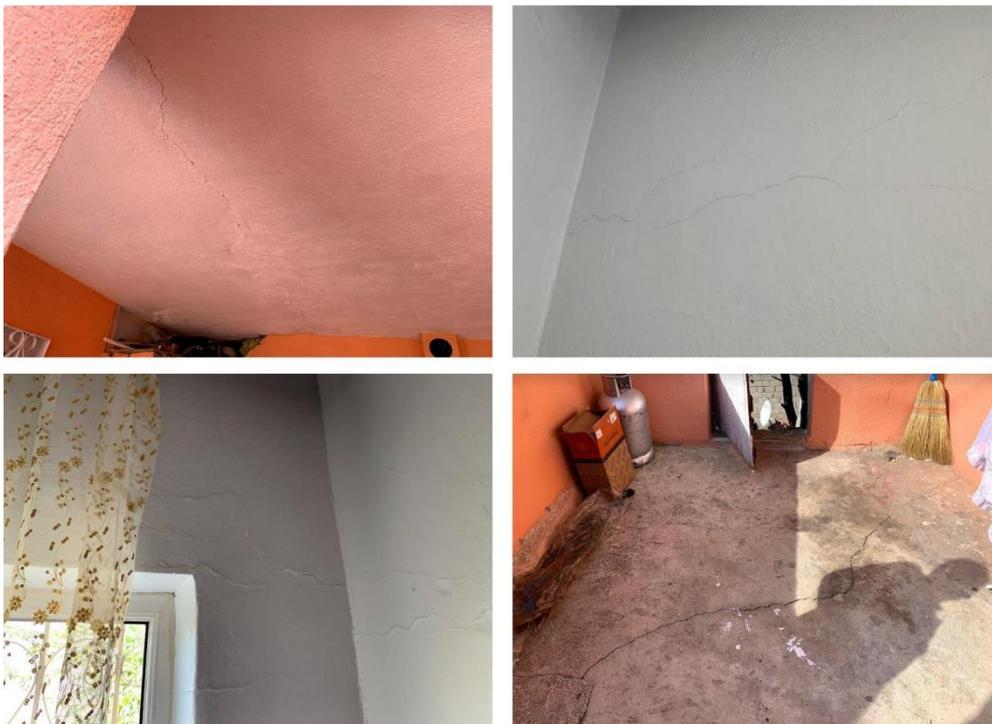
The 2nd building is classified as "c class; reinforced concrete building" among the types of buildings that can be damaged due to blasting depending on the vibration speed values. Therefore, the V<sub>0</sub> speed in the foundation of the building should not exceed 10 mm/sec according to Table 3. The fact that the V<sub>0</sub> speed calculated according to V\*1/2 is 3.45 mm/sec showed that the vibration caused by the blasting cannot cause damage to the 2nd building. However, as the tunnel route is in the direction of the 2nd building, the distance from the blast point to this building become shorter and shorter as it moves through the tunnel, and the potential of the building to receive damage due to the effect of increasing vibration. It is known that seismic waves continue to propagate until their energy is depleted. There are two reasons for the energies of such waves to be extinguished. The first is the physical and geological resistance of the rock structure, and the second is the geometrical spread of the seismic wave to a wider area as it moves away from its source. Massive andesites in the area where the 1st building is located transmit the energies of seismic waves faster. On the other hand, cracked and weathered granites in the area of the 2nd building absorb the energies of seismic waves more quickly.

As a result of the damage examination carried out on the 2nd building, it is observed that deep and surface cracks are formed on the load-bearing walls of the building, there are spillages in the wall plaster, deep cracks are formed in the surrounding pavements, and cracks are formed in the ceiling floors. The visuals of the damage detected on the building are given in Figure 9.

**Figure 9.** Damaged parts of the 2nd building

The damaged parts detected on the building are located on the masonry walls and ceiling reinforced concrete floors that form the carrier system of the building. Crack openings in the walls vary between 1-3 mm.

Considering the current condition, age and depreciation of the building, it will be more appropriate and reliable to demolish and rebuild it. As such, it does not seem appropriate to live in the building.
