## Investigation of the structural damage caused by blasting activities in tunnels to surrounding buildings: The case of Gümüşhane belt highway

Mehmet Tevfik SEFEROĞLU<sup>1</sup>

<sup>1</sup>Gümüşhane University, Department of Civil Engineering, 29100, Gümüşhane, Türkiye

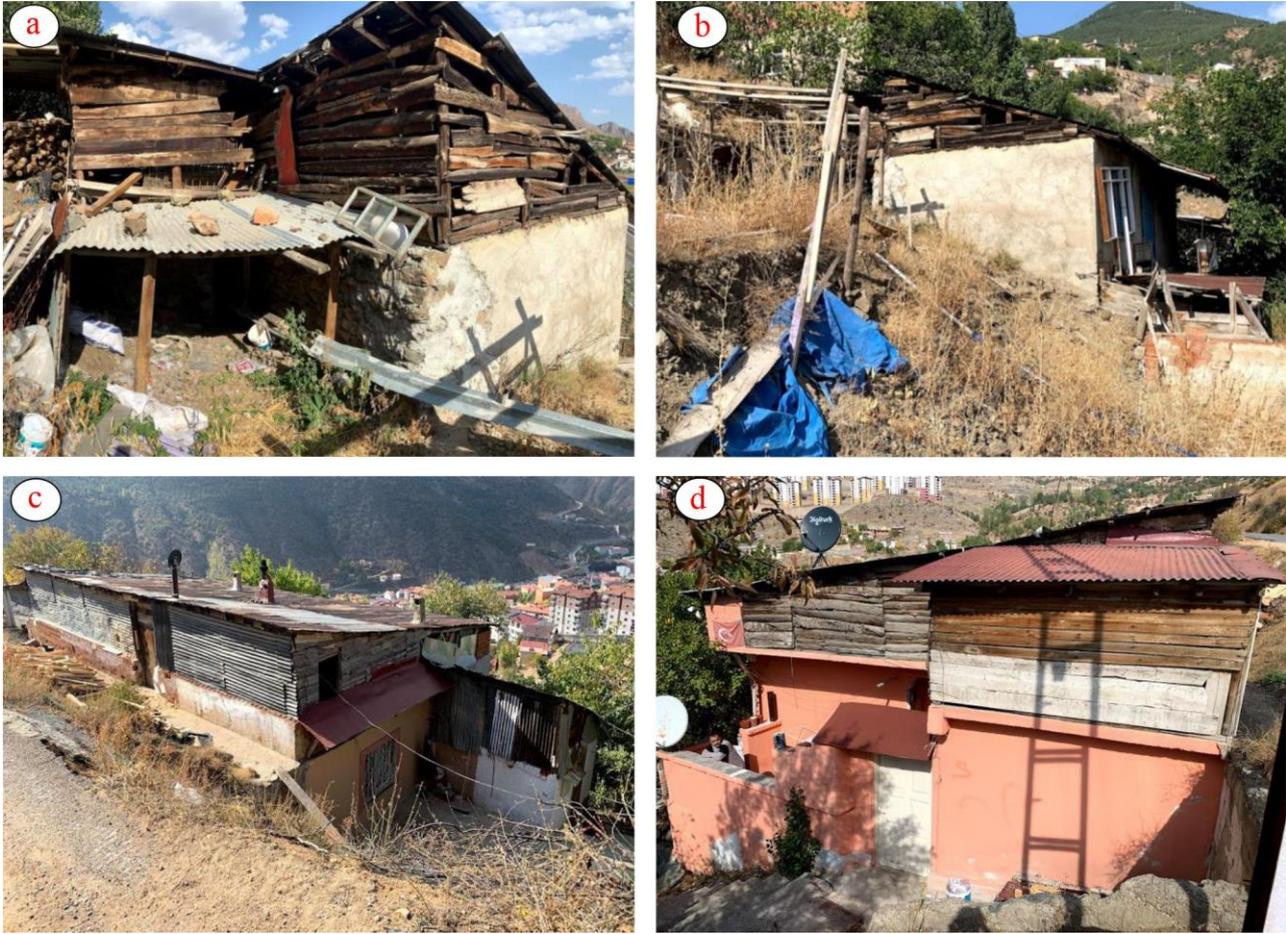
The 1st building is built in masonry style and is plastered both inside and outside. The building is single storey. The 2nd building is built in reinforced concrete style and is plastered inside and outside. This building consists of two floors, including the penthouse. The buildings are about 40-45 years old. General views of the buildings are given in Figure 6.

**Figure 6.** General views of the buildings; (a, b) 1st and (c, d) 2nd building
